CHAPTER 10

LANDSLIDES

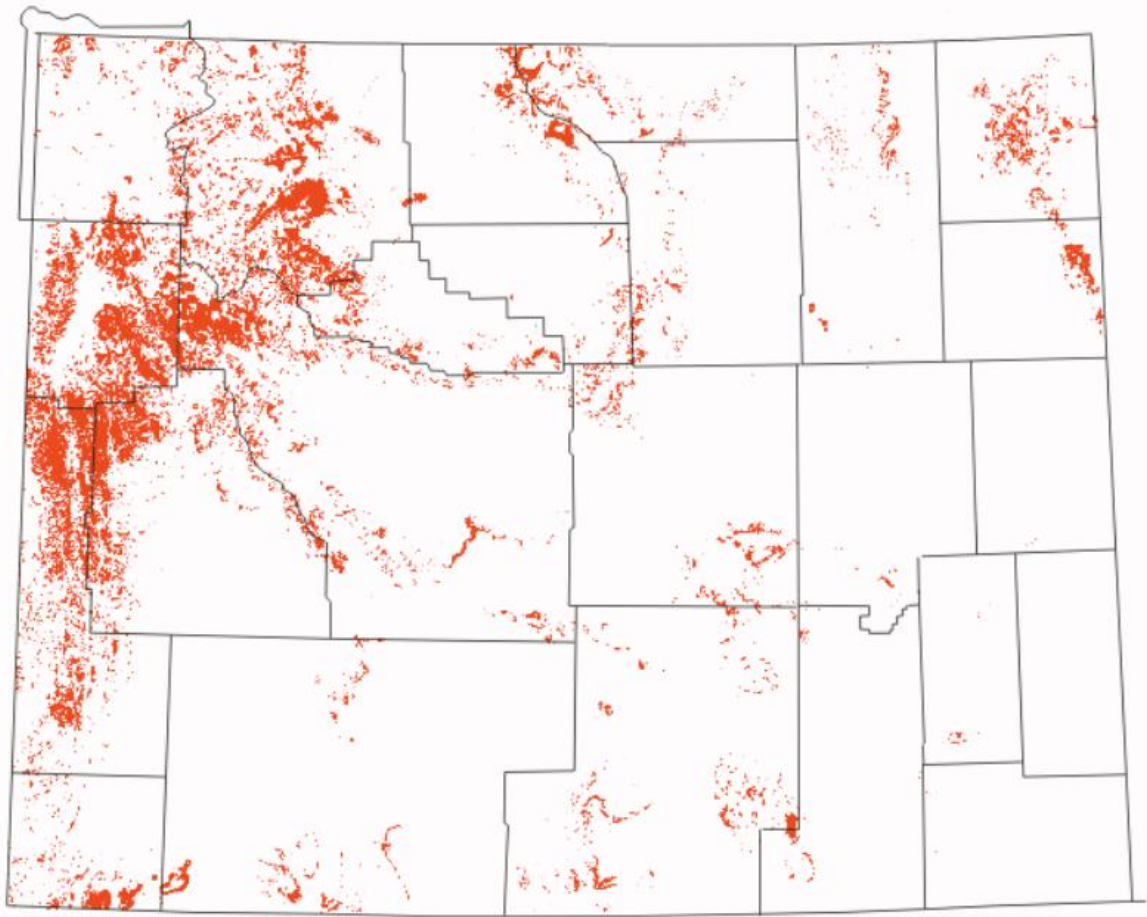
Figure 10.1. Mapped Landslides in Wyoming

Landslides are one of the most common geologic hazards in Wyoming, with some of the highest landslide densities in the country found in the State. The figure below shows mapped landslides in Wyoming.

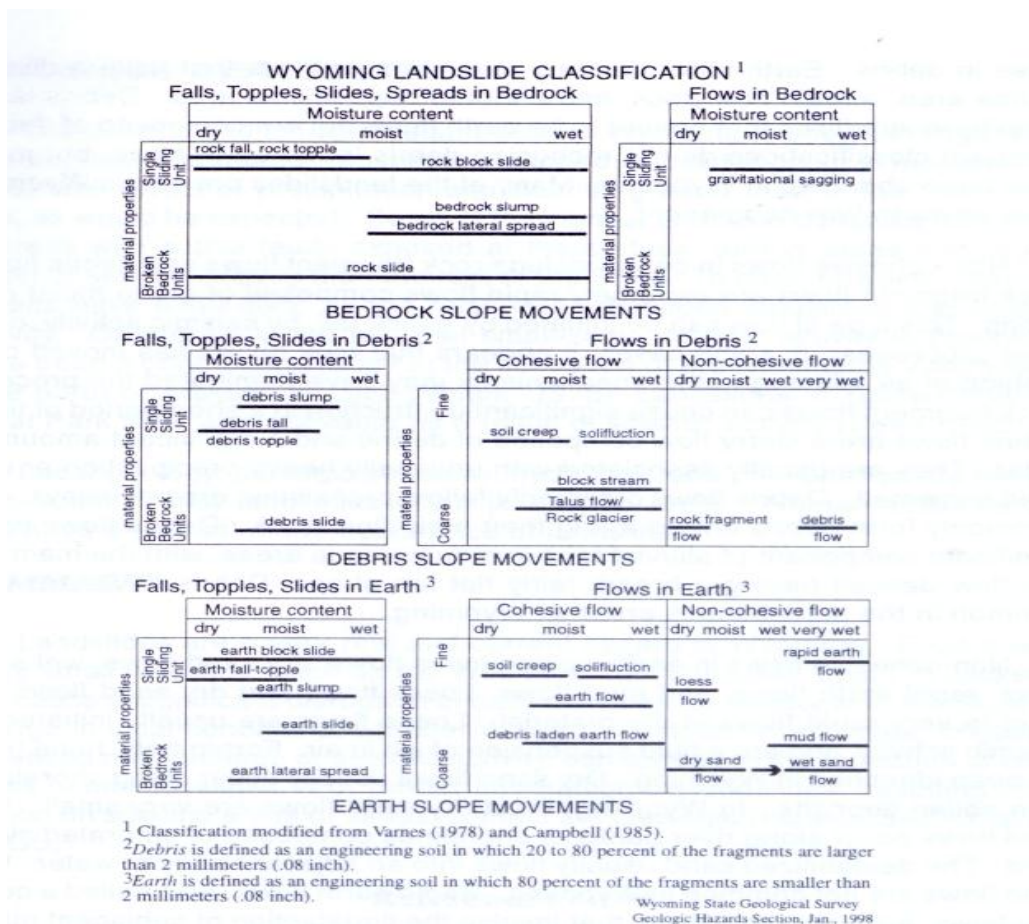
Figure 10.2 Wyoming Landslide Classifications

There are many types of landslides present in Wyoming. In order to properly describe landslide type, the Geologic Hazards Section developed a landslide classification modified from Varnes (1978) and Campbell (1985). As can be seen in Figure 10.2 there are five basic types of landslides that occur in three types of material. Falls, topples, slides, lateral spreads, and flows can occur in bedrock, debris, or earth. While individual landslide types can occur in nature, most landslides are complex, or composed of combinations of basic types of landslides.

Falls and topples are easy to visualize. In a fall, material detached from a steep slope or cliff descends through the air, and may bounce and roll. In a topple, a mass rotates forward on a pivot point. If a toppling mass pivots far enough, a fall may result.

Slides are characterized by shear displacement along one or several surfaces. Two general types of slides are recognized: rotational and translational. In a rotational slide, the surface of rupture is concave upward, and the mass rotates along the concave shear surface. Rotational slides are usually called slumps, and they can occur in bedrock, debris, or earth. In a translational slide, the surface of rupture is a planar or gently undulatory surface. In bedrock and earth, translational slides are usually called block slides if an intact mass slides down the slope. If rock fragments or debris slide down a slope on a distinct shear plane, the movements are called rock slides or debris slides. It is easy to see that confusion can result by applying the term “slide” to all types of landslides.

Lateral spreads are characterized by lateral extension movements in a fractured mass. Lateral spread movements may occur in bedrock and soil as a result of liquefaction or plastic flow of subjacent materials, or in bedrock without a well-defined basal shear surface or zone of plastic flow. Lateral spreads in bedrock without a well-defined zone of shearing or flow, usually occur on ridge crests.

In general, a flow is a moving mass that has differential internal movements that are distributed throughout the mass. While most flows occur in debris and earth, one type of flow, gravitational sagging, does occur in bedrock. Flows in debris and earth can be cohesive or non-cohesive. Both cohesive and non-cohesive flows are further subdivided by water content and material properties.

Most landslides mapped in Wyoming are classified as being complex. For example, many landslides in the state are slump/earth flow complexes. That type of landslide is composed of a slump at its head, with the main body and deposit being an earth flow. Block slides often grade into rock slides, which can further grade into earth flows or debris laden earth flows. Such a movement would be classified as a block slide/rock slide/flow complex.

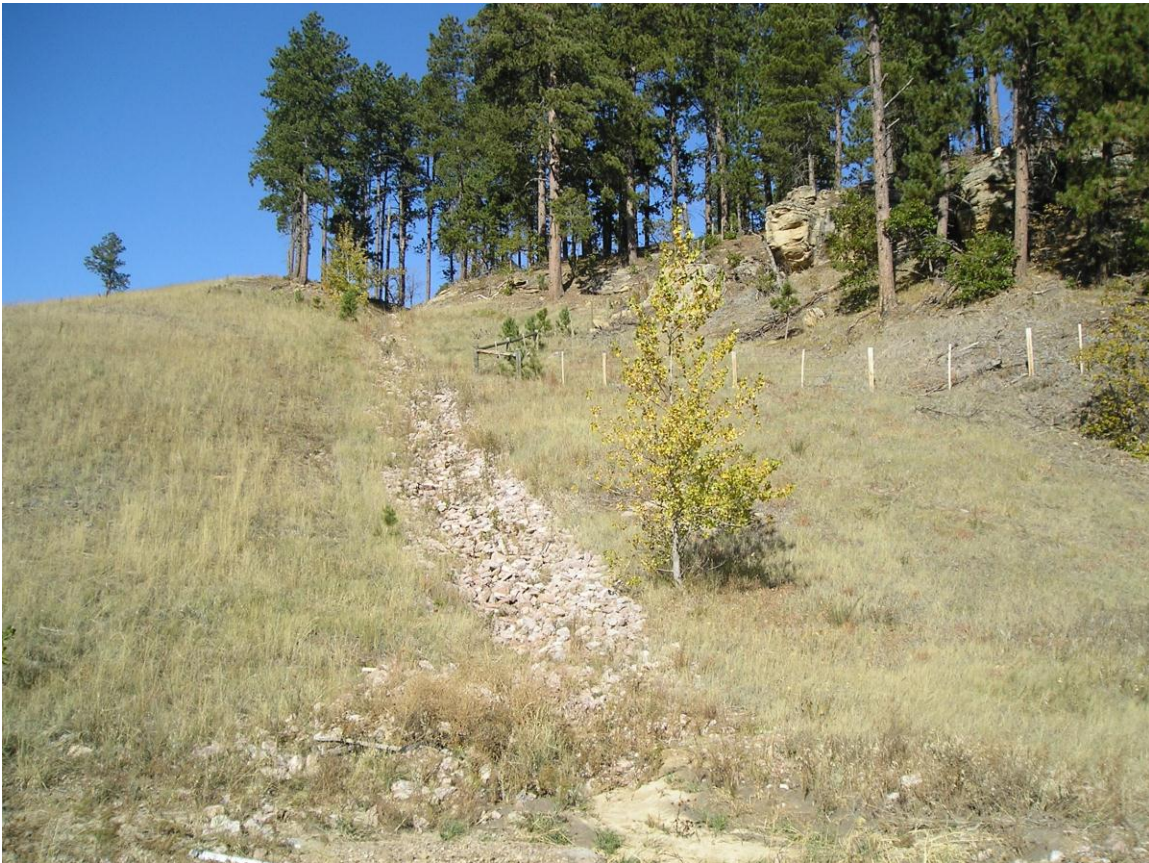
Figure 10.3 Old slide area on State Highway 14 between Sundance and Devils Tower

Sundance West Quadrangle: Several blockslide/slump complexes are present approximately 3-4 miles west of Sundance (T51N R63W Section 17). U.S. Highway 14 cuts through one of the landslides. If the landslides destabilized, damage could occur to the highway. In addition, a blockslide/slump complex on the eastern side of Coal Mine Hill (T51N R63W Section 19 and T51N R64W Section 24) poses a threat to nearby structures if it were to destabilize. The slump and the blockslide/slump complex northwest of Sundance in T51N R63W Section 4 may damage nearby roads and campgrounds if they were to destabilize. A slump complex in T52N R63W Section 18 and a blockslide/flow complex in T52N R64W Section 13 are present along a county road. If the landslides destabilize, the county roads could be damaged. Slope stability may be affected by heavy periods of precipitation or significant development.

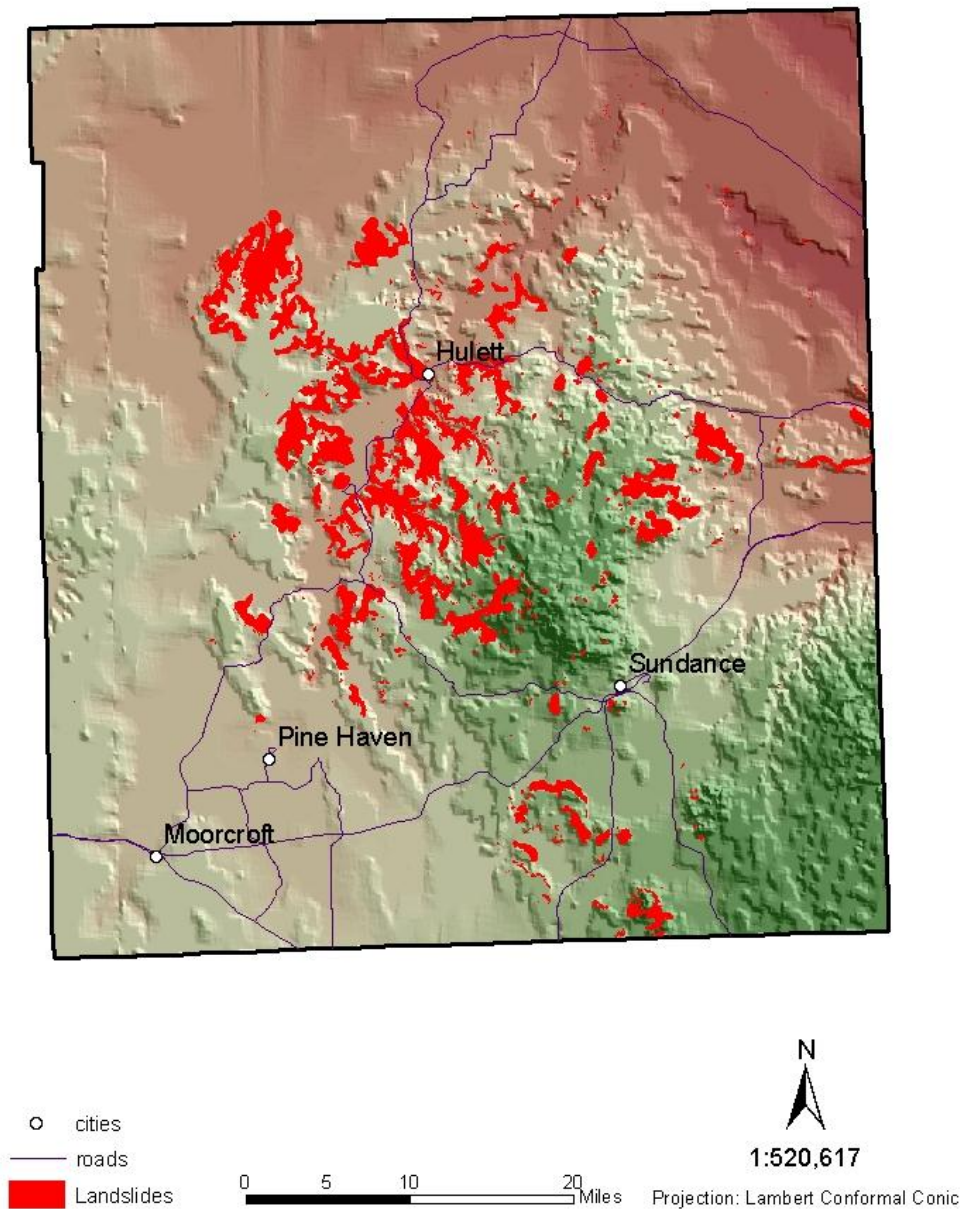
Figure 10.4 Mapped Landslides in Crook County

Mapped landslides for Crook County are shown on the figure below.

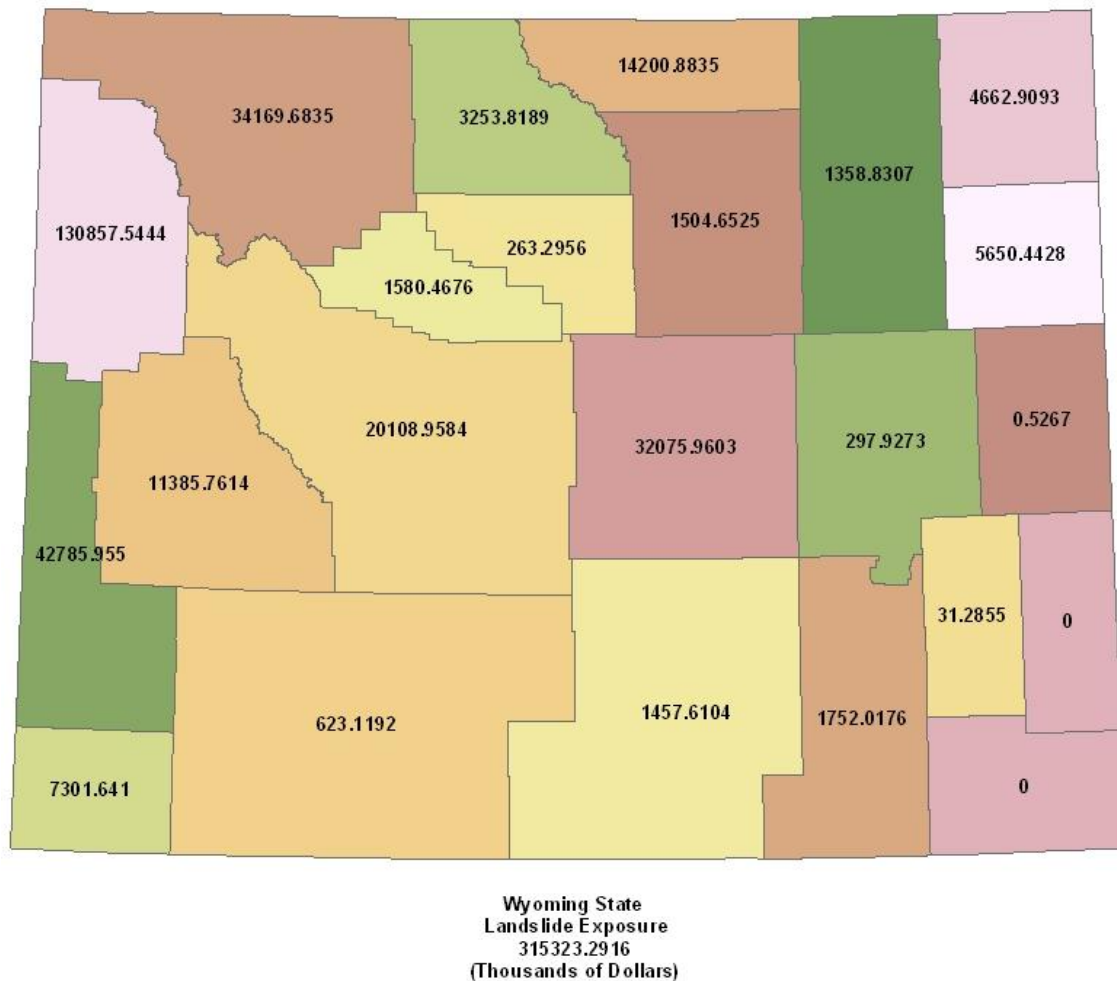
Figure 10.5 Wyoming Landslide Exposure by County

For the 2008 Wyoming Multi-Hazard Mitigation Plan, the WSGS calculated the building exposure value for buildings that may occur in or within 100 feet of a mapped landslide. All landslides mapped in Wyoming have been digitized. The landslides then had a 100-foot buffer digitally added to the outside of the landslides. The modified landslides were then digitally crossed with census block building values. In some cases, a landslide boundary will dissect a census block. In that case the proportional value of buildings in the census block will be assigned to the landslide. If a census block is within a landslide, then the values of all the buildings in the census block is assigned. The values derived by county are shown in Figure 10.5 below. Table 10.1 shows the ranking of counties based upon landslide building exposure values.

As can be seen above, there is approximately \$4.6 Million in building value that is built on or near landslides in Crook County. More detail for the County is provided in Figure 10.6.
